## CANARY CASE REPORT: WHAT CAUSED THE PULPITIS?

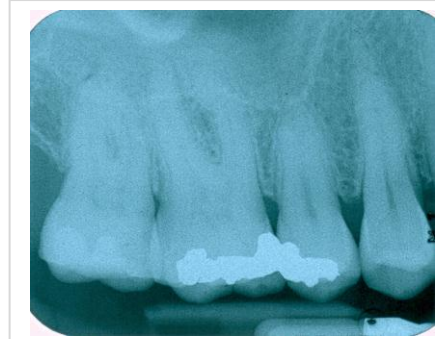
On examination, the soft tissues in the area were normal with no sign of swelling or a fistula. Periodontal pockets were all 3 mm. in depth or less. The restorations on the maxillary right second and first molar as well as on the bicuspid were intact with no evidence of marginal breakdown. Periapical radiograph showed the restorations were of moderate depth with no evidence of apical change. There was a small radiolucent area at the tip of the roots of the maxillary second molar but there were no symptoms associated with this tooth.

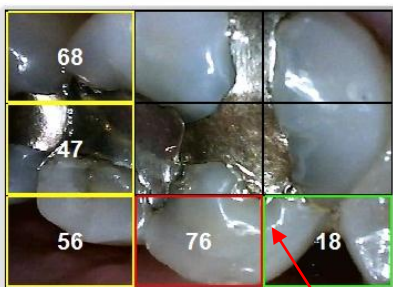
**76** Disto-Lingual Cusp

LEFT: Canary Scan results. Canary Number 76 on disto-lingual cusp.

RIGHT: Photograph with amalgam removed.

The patient returned to start endodontic treatment six days later. She had not taken her antibiotics and reported that the pain was still present but “it did not feel like the other two teeth that needed root canal”. The tooth responded to hot, cold and percussion. A Canary Scan was done on the tooth and around the mesial portion of the amalgam the Canary Numbers were 68, 47 and 56 (from buccal to lingual). There was also a 76 around the disto-lingual cusp. Upon removal of the amalgam, caries was found around the mesial portion of the preparation, under the disto-lingual cusp and there was a crack on the pulpal floor beneath the distal pit.

The caries was removed, cracked area prepared and the tooth restored with a flowable composite and heavily filled posterior composite. There have been no symptoms in the few weeks.
