CANARY CASE REPORT: DETECTING CARIES BENEATH AN AMALGAM RESTORATION

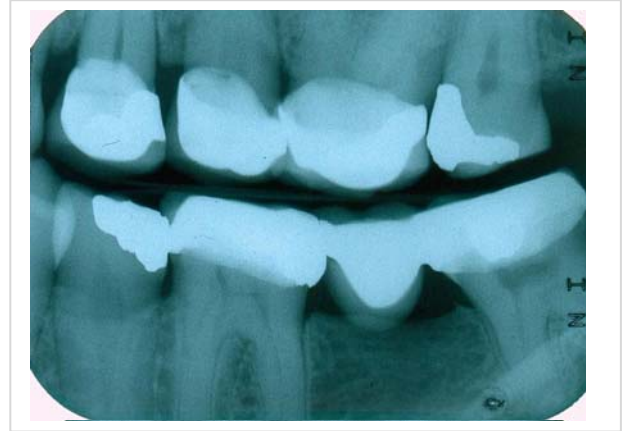
The concern was the integrity of the margins of the amalgam restoration. The hygienist obtained Canary Numbers of 60 on the mesial marginal ridge and 39 on the buccal cusp, which indicated caries and microleakage around this amalgam. This patient had resisted replacing a number of old restorations. The Canary Scan allowed the hygienist and dentist to locate the caries on this tooth (not seen on radiographs) and educate the patient about disease progression and detection.

LEFT: Canary Scan results. Canary Number 60 on mesial marginal ridge and Canary Number 39 on buccal cusp.

RIGHT: Photograph with amalgam removed.

Removal of the restoration revealed a large carious lesion under the mesial aspect of the buccal cusp (Canary Number 60) and caries also on the mesial margin (Canary Number 39). Had the caries not been detected, it would have led to either a pulp exposure or continued to undermine the buccal cusp leading to a fracture.
