View from the Chairside – Detecting Cracks in Teeth Using the Canary System

A Clinical Challenge & Solution: Detecting Cracks in Teeth Using PTR-LUM-The Canary System; A Case Report

Stephen Abrams^{1 2,*}

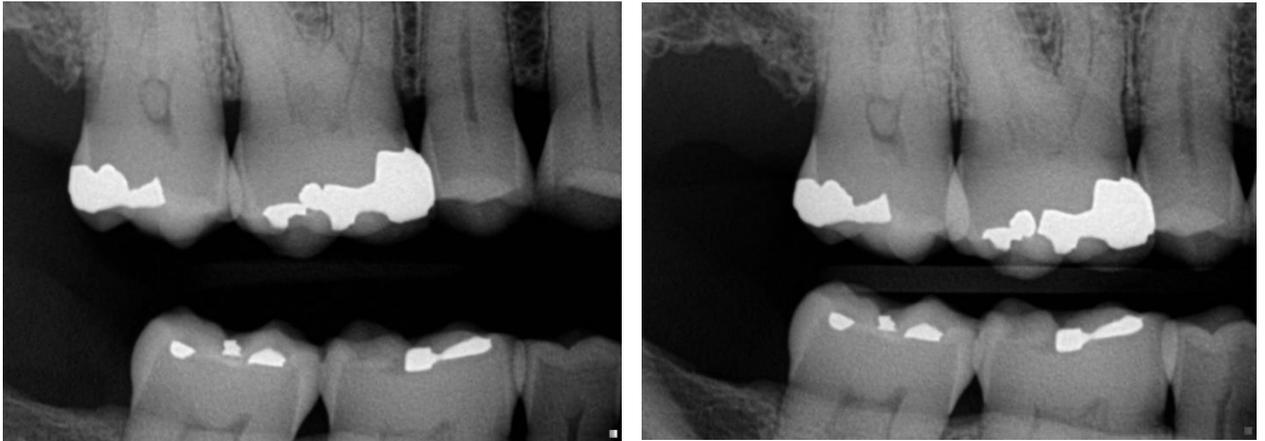
Figure 1 Bitewing Radiographs of the Right Posterior Teeth taken 3 months before pain occurred

Radiographs taken three months prior to the pain occurring, did not indicate any caries or cracks on the mandibular first and second molar or on the distal surface of the mandibular right second bicuspid. The

maxillary first molar had a large amalgam restoration but there was no pain on hot, cold, percussion or occlusal loading. The amalgam restorations on the mandibular molar teeth appeared very shallow.

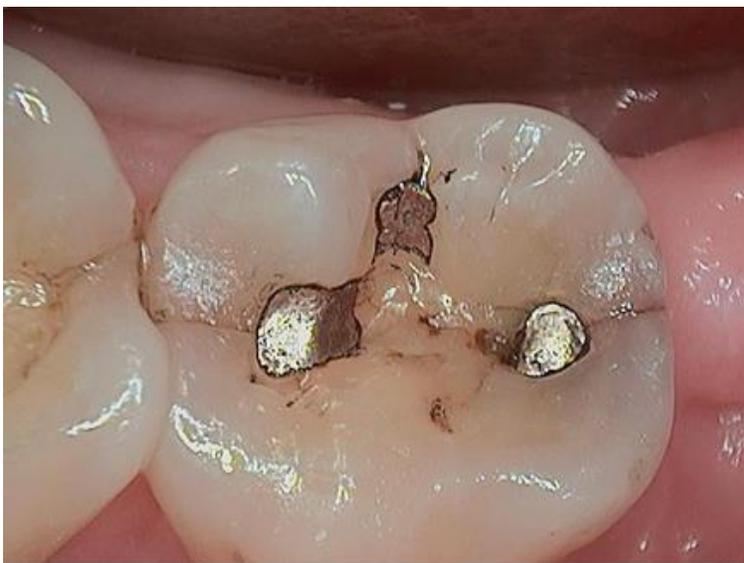
Figure 2 Occlusal view of the Mandibular Right Second Molar

On examination, the pain appeared to be focused on the mesial portion of the mandibular second molar and distal portion of the mandibular right first molar. The image below shows the clinical condition of the occlusal surface of the mandibular second molar. There were three shallow amalgams placed in the central area of the occlusal surface over 25 years ago. There were stained grooves on both the mesial and distal marginal ridges. There was a grey shadow on the distal aspect of the distal amalgam. The bite wing radiograph did not indicate that there was caries on the distal aspect of the tooth and visual examination did not show any open lesion or staining on the distal surface.

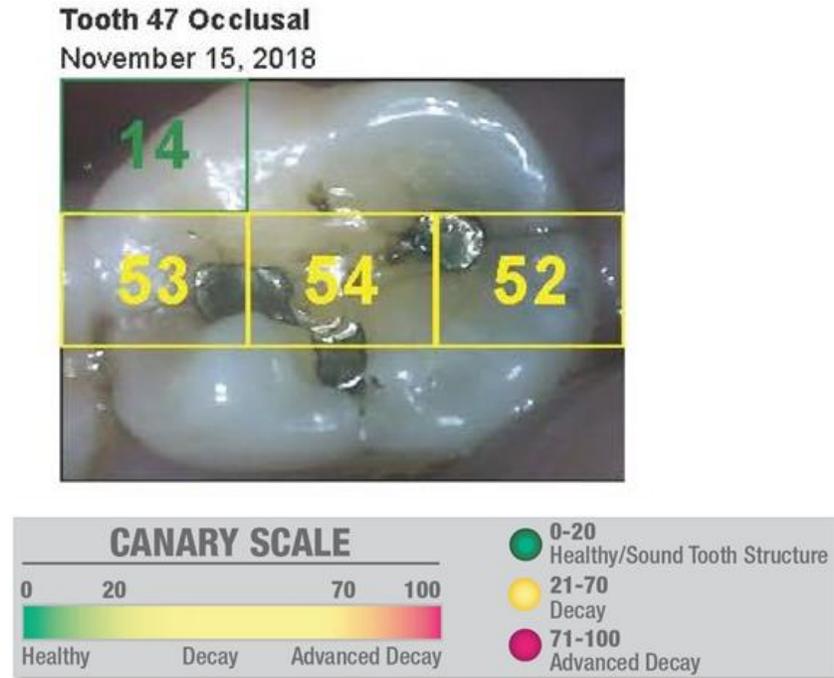
Figure 3: Canary Scan of the Occlusal Surface of the Mandibular Right Second Molar. The Canary Scale indicates that there are defects in the crystal structure of the tooth in three locations requiring treatment.

The Canary System was used to scan and examine the occlusal surfaces of the mandibular right second molar. The intra-oral camera image was used to record the location of the various readings. Canary Numbers above 20 indicated that the crystal structure of the tooth was not intact. The Canary examination of this tooth indicated that the marginal ridges and central pit all have caries and or cracks.

The Canary Number (ranging from 0 – 100) is created from an algorithm combining the PTR and LUM readings and is directly linked to the status of the enamel or root surface crystal structure [33, 34]. A Canary Number of less than 20 indicates a healthy tooth surface. Any Canary Number above 20 indicates a defect in the tooth structure [35]. In this clinical situation, the Canary Numbers were above 50, indicating large cracks or extensive cracks along the marginal ridges and caries in the central pit. These cracks were found upon preparation of the tooth for the restoration.

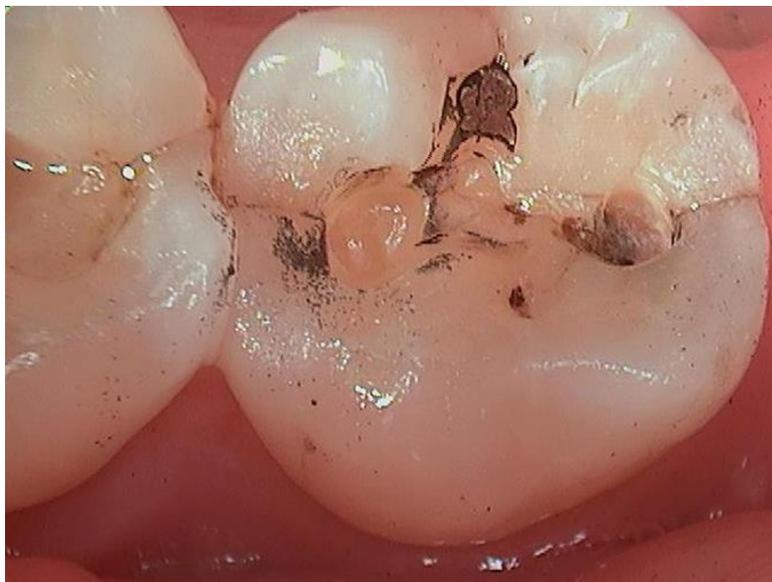
Figure 4 Initial Removal of the Amalgam showed cracks on both marginal ridges and some cracks or caries in the central pit.

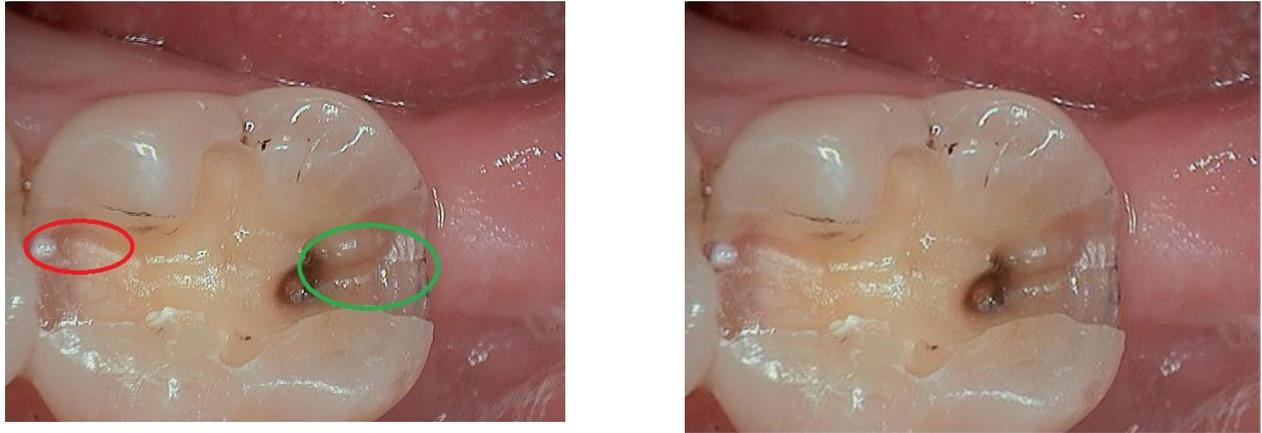
Figure 5 Image taken after removal of the amalgam and preparation of the proximal boxes. There are still cracks present on the mesial and distal proximal boxes. The circles indicate areas of concern / pathology

Upon removal of the amalgams, cracks were found on the mesial (red circle) and distal proximal boxes (Figure 5). The crack on the distal appeared to be much more extensive (Figure 5 green circle). There was also some demineralized dentin beneath the amalgam on the distal and some stain from the amalgam (indicated with the green circle). On removal of the amalgam in the central pit, we noted a small crack and leakage around the amalgam margin.

The MOD preparation was completed and a bonded composite restoration was placed. This restoration has been placed 6 months and the patient has had no pain on temperature change or on chewing. We are now currently assessing her to see if there is any evidence of parafunction and may consider placement of a bite splint in the future.
